Description : Sample Name SVZ-1XXX/2XXX-PM-PCT Series Multi touch
display monitor
Model Name SVZ-1XXX/2XXX-PM-PCT
Date of Received Apr. 29, 2020
Date of Testing May. 04, 2020

Conclusion	Test Information	Q'ty	Test Result	Page
	Mechanical Shock Test	1	PASS	3
	Vibration Test	1	PASS	5

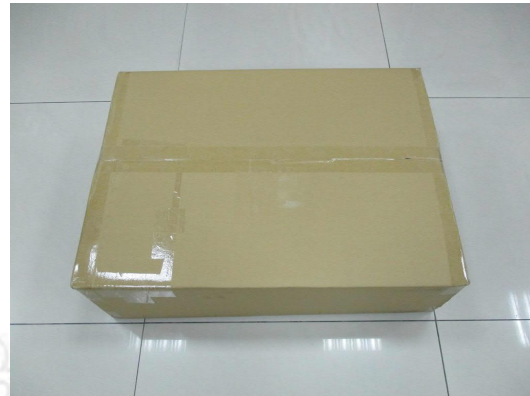
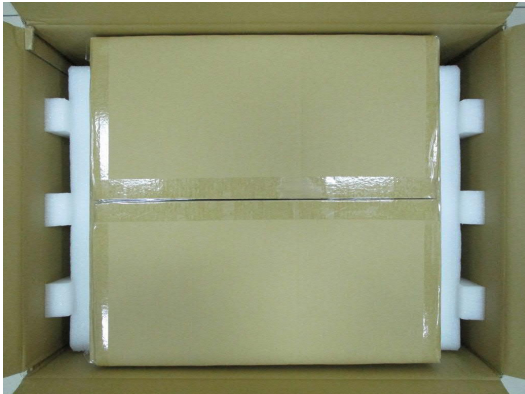
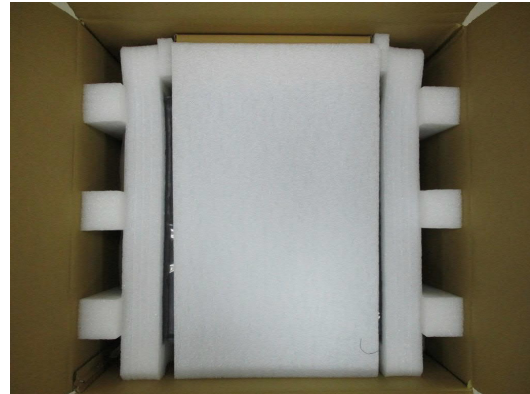
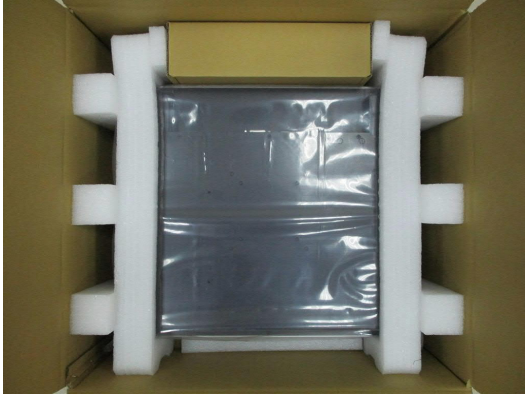
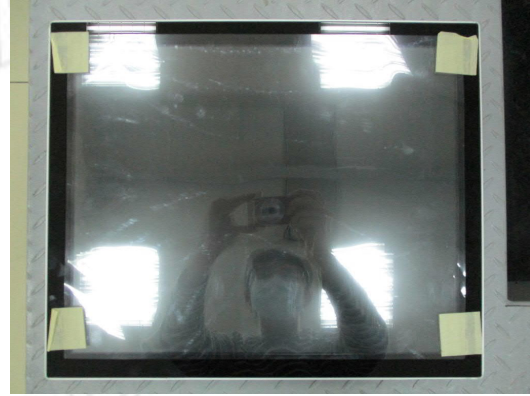
1-4 After Test -1

1-5 After Test -2

1-6 After Test -3

1-7 After Test -4

1-8 After Test -5

- There is no visible damage on the unit.
- The function is normal after the test.

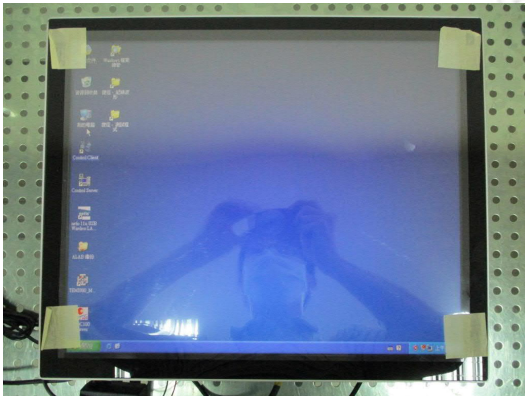
1-9 After Test: Function Check

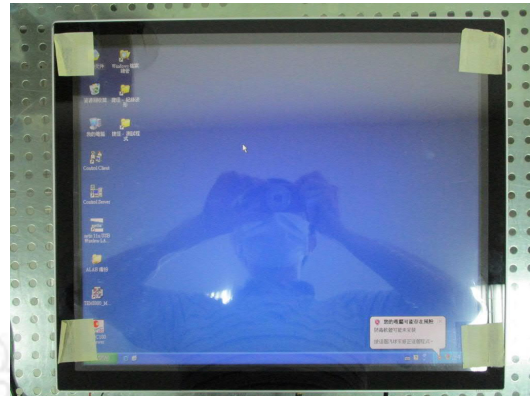
2-4 After Test: Function Test

- There is no visible damage on the unit.
- The function is normal after the test.
